NPIC/R-1259/64 June 1964

PHOTOGRAPHIC INTERPRETATION REPORT

BOMB DAMAGE ASSESSMENT PHONG SAVAN AIRFIELD AND AAA SITE, XIENG KHOUANG, LAOS

MISSION LUCKY DRAGON 25X1

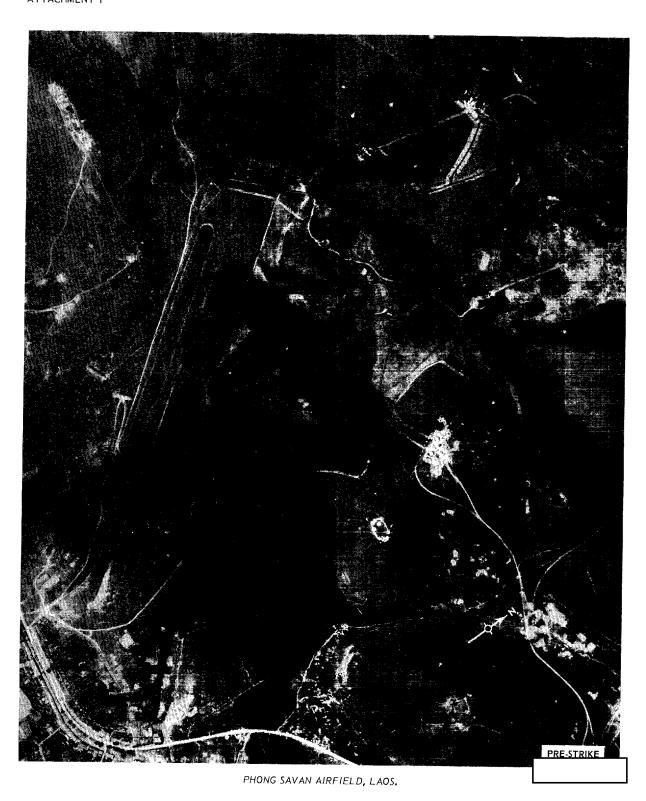
NPIC/R-1259/64 ATTACHMENT 1

Phong Savan airfield is situated 11 nm NW of Xieng Khouang, Plaine des Jarres area, 19-27N 103-13E. It consists of a 3,000 x 160 ft NW/SE serviceable sod runway. Facilities include four support buildings immediately west of the SE end of the runway. See attachment 1.

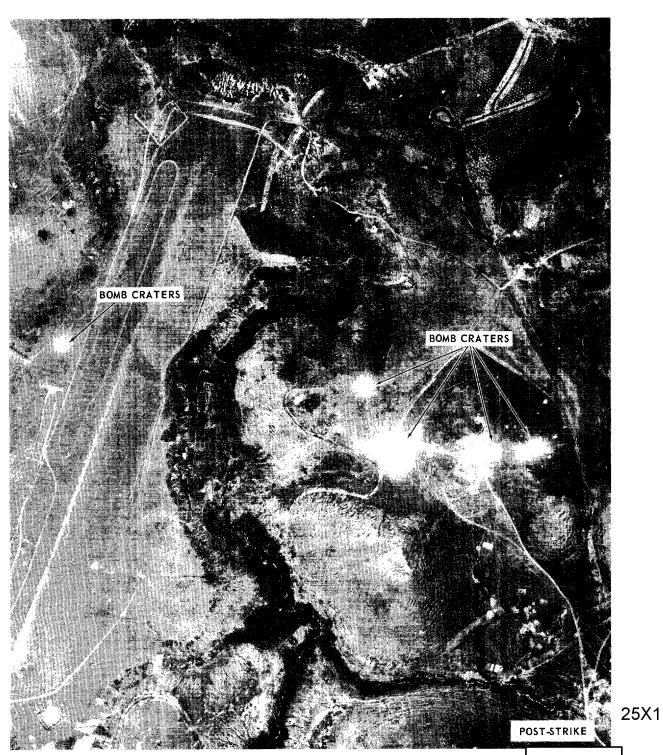
NPIC. R-1259/64 ATTACHMENT 2

Phong Savan airfield was attacked by four USAF F-100 aircraft on ______ The amount of expended ordnance is not known, however, 11 bomb craters and two probable bomb craters are observed near the airfield. No direct hits were recorded on the airfield and it remains serviceable. All but two of the hits were recorded to the north, with one observed near the extreme edge of a strongpoint resulting in only superficial damage. The strongpoint appears to be occupied at the time of post-strike photography, with at least two occupied automatic weapons positions and numerous trenches and firing bays observed throughout the area. The two previously reported occupied 37 mm AAA positions now appear unoccupied. No strike photography is available for determination of occupancy at the time of the strike. See attachment 2.

The craters observed at Phong Savan airfield are tabulated as follows:

PHONG SAVAN AIRFIELD, LAOS.

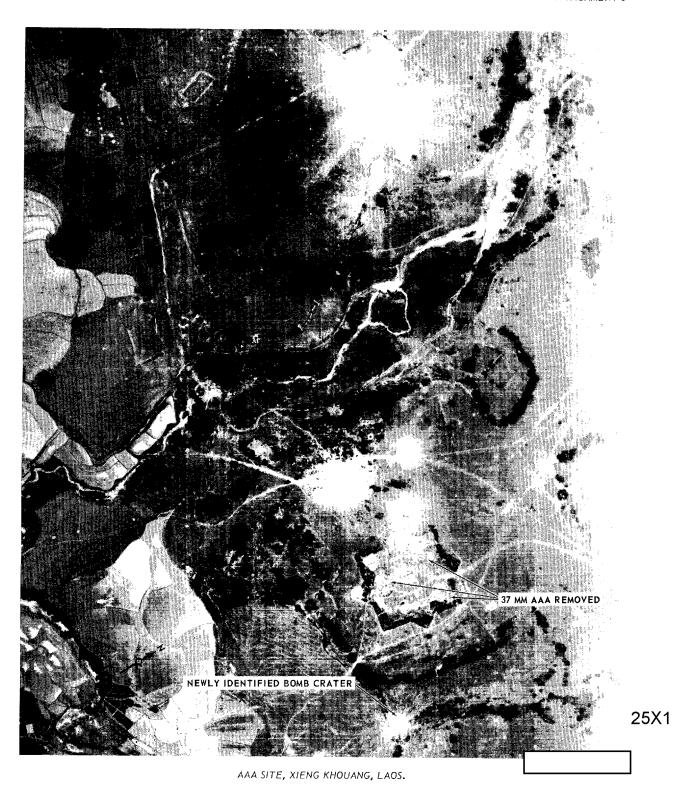
NPIC/R-1259/64 ATTACHMENT 3

NPIC/R-1253/64, "Bomb Damage Assessment, AAA Site, Xieng Khouang, Laos," based on Mission reported nine bomb craters on and west of the site, and one possible dud impact crater also west of the site. A review of LUCKY DRAGON a re-evaluation of Mission tenth bomb crater approximately 300 ft east of the SE corner of the site. The site now appears to be unoccupied. The two trucks reported within the site have been removed. No activity is observed within the area. See attachment 3.	25X1 25X1 25X1
	25X1
